# 930,599 Mile Engine 1 Million Mile Van

# Delivery Driver Tests AMSOIL

# CHRONOLOGY OF ANALYSIS

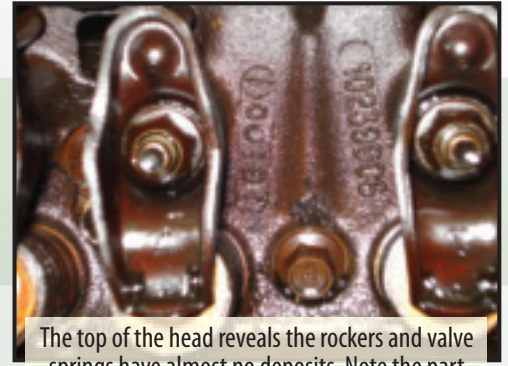
The top of the head reveals the rockers and valve springs have almost no deposits. Note the part numbers still are visible.
