# 930,599 Mile Engine 1 Million Mile Van

# Delivery Driver Tests AMSOIL

# CHRONOLOGY OF ANALYSIS

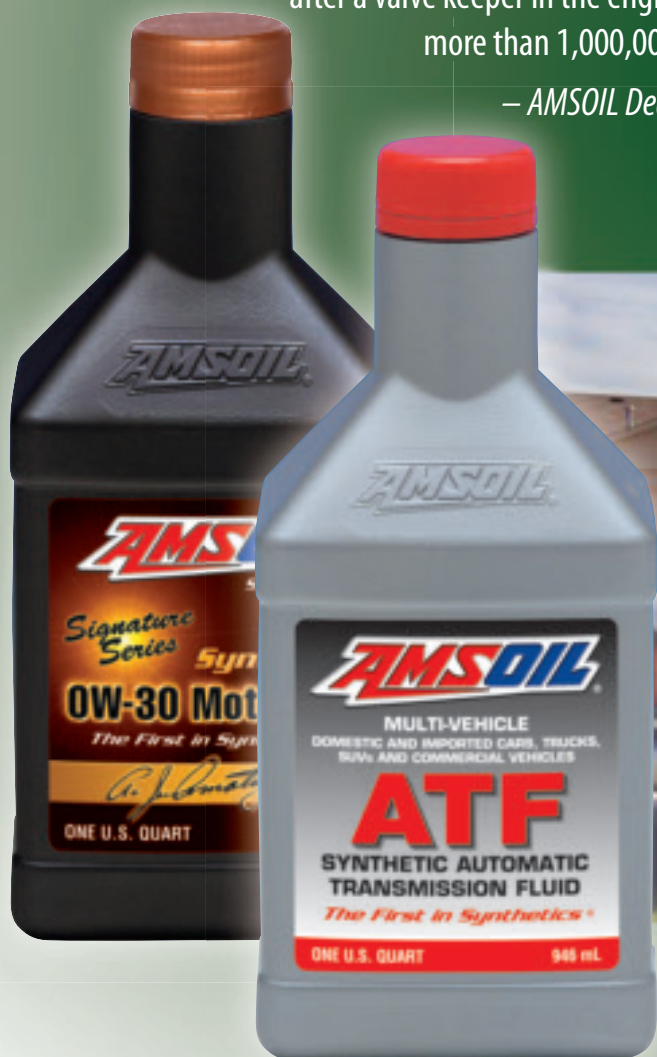
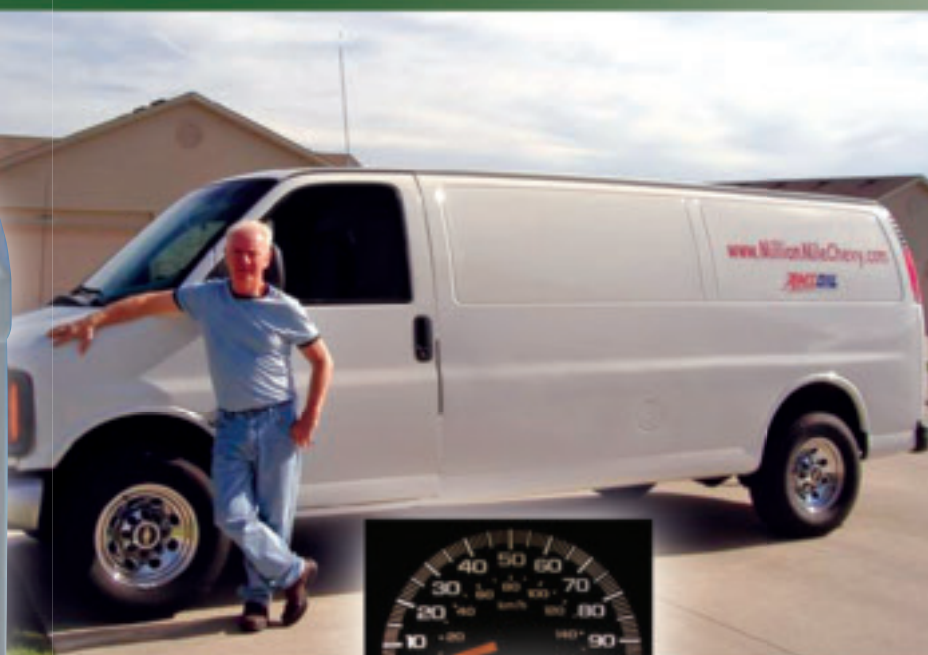
Schlimmer sent the engine to AMSOIL INC. for analysis. Analysis showed that a valve keeper had worn out, causing the valve to become wedged in the chamber. The problem with the engine was not oil-related. Measurements taken against manufacturer's specifications indicated the engine was still in useable condition. In each of five categories, the engine tested within 1 percent of manufacturer's original specifications for the engine. (See chart below)

Schlimmer replaced the engine and continues to drive the van with the original transmission with more than 1 million miles of service.
